Case study

Enhancing Durability and Efficiency in a Concrete Plant

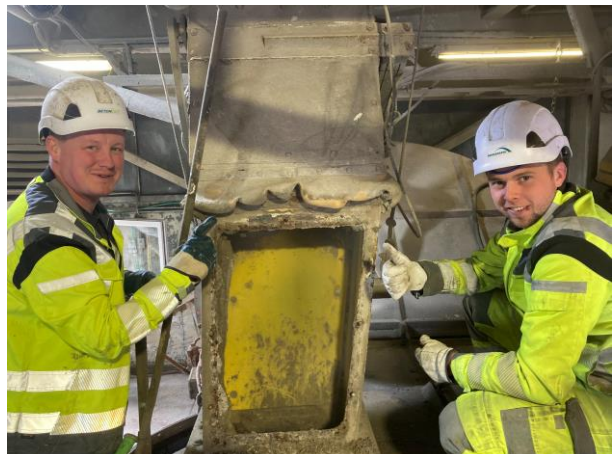
A concrete plant located in Austria encountered issues with a transition chute constructed from Hardox material, which connected the Aggregate scale to the mixer. The chute experienced rapid wear and adhesive product buildup, disrupting operations and requiring frequent maintenance.

*After 33 month/200,000 m3 processed, hardly
any abrasion detectable (Hardox service life
approx. 30,000 m3)
Mixing master*

To address these challenges, the plant implemented a solution by replacing the worn Hardox chute with a 6mm Tecthan™ plate with perforated metal inlay for easy installation and replacement. This strategic upgrade resulted in remarkable improvements, with minimal wear observed even after 33 months of continuous operation and approximately 200,000 cubic meters of material processed.
